IMPORTANCE OF SEISMIC SAFETY OF NONSTRUCTURAL ELEMENTS IN HOSPITAL BUILDINGS

Poor Seismic Performance of NSEs in Hospital Buildings Objectives

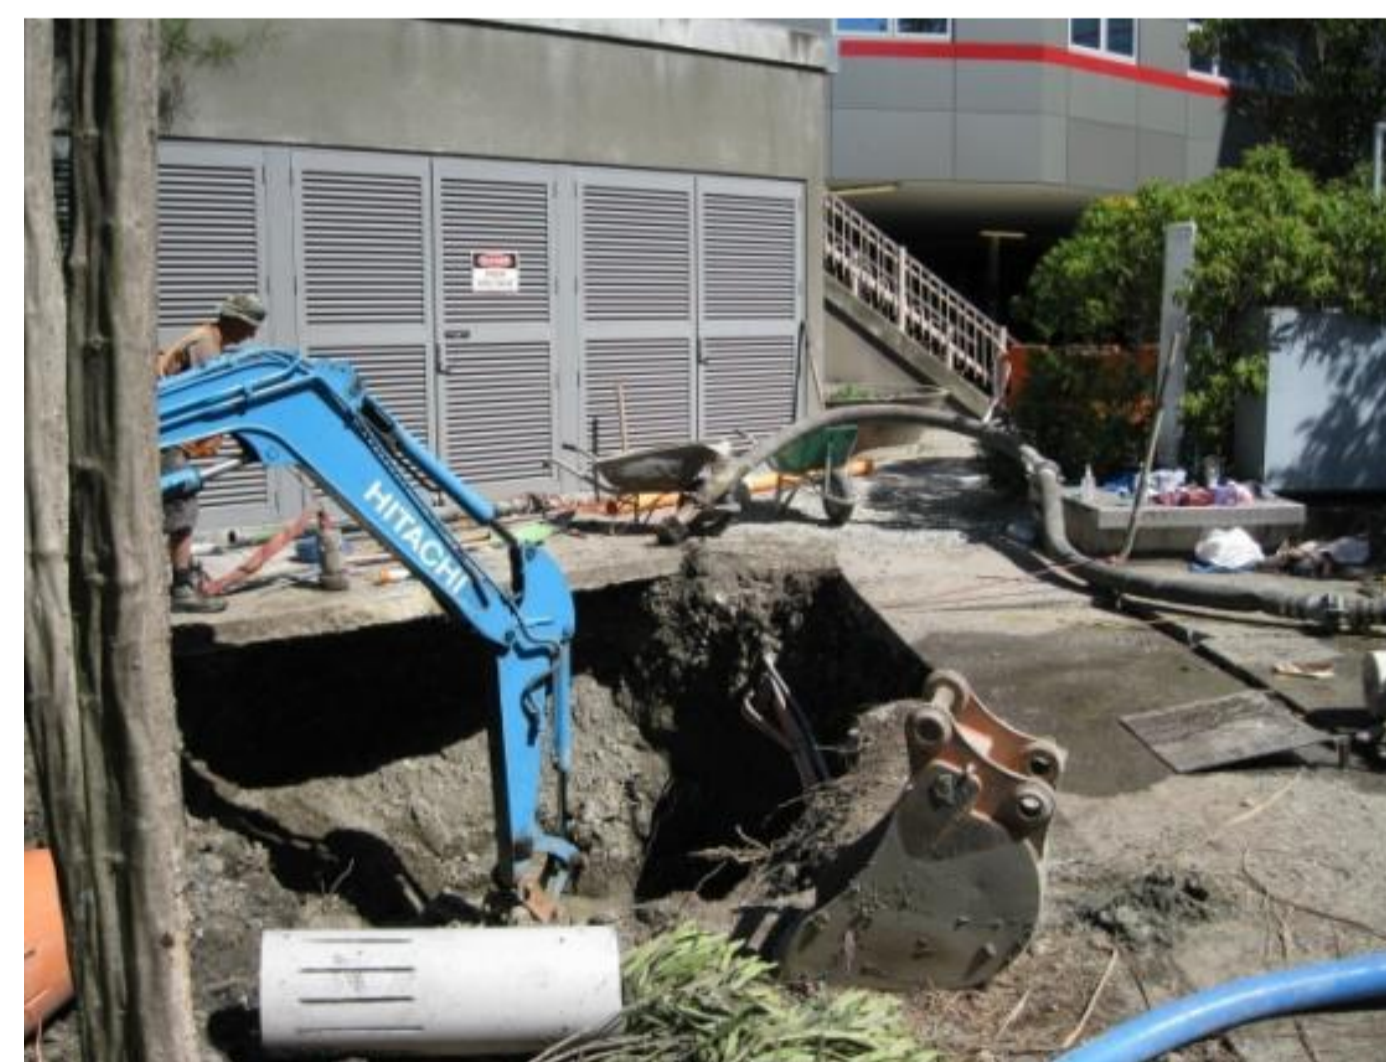
Fig. 2 – Damages to Sewer Lines due to Liquefaction, 2011 Christchurch earthquake [McIntosh, 2012]

- Attached to the structural systems, but not a part of load resisting systems
 - Prefabricated panels, ceilings, storage racks, HVAC, fire sprinklers, transformers, generators, pipe ducts, medical equipments
- Vital for the daily operations of healthcare systems
- Accounts for roughly 92% of the total cost of hospital structures
- History of past earthquakes
 - Most of the hospitals lost its function due to failure of NSEs though the structural element remains intact
 - e.g., Christchurch earthquake, New Zealand 2011-Breaking of sewer lines caused geotechnical failure (Liquefaction) in Women's hospital and partly buried cars
