QUANTIFYING PARAMETERS FOR IMPROVED ENERGY DISSIPATION CAPACITY IN LOW-RISE RC OPEN STOREY BUILDINGS

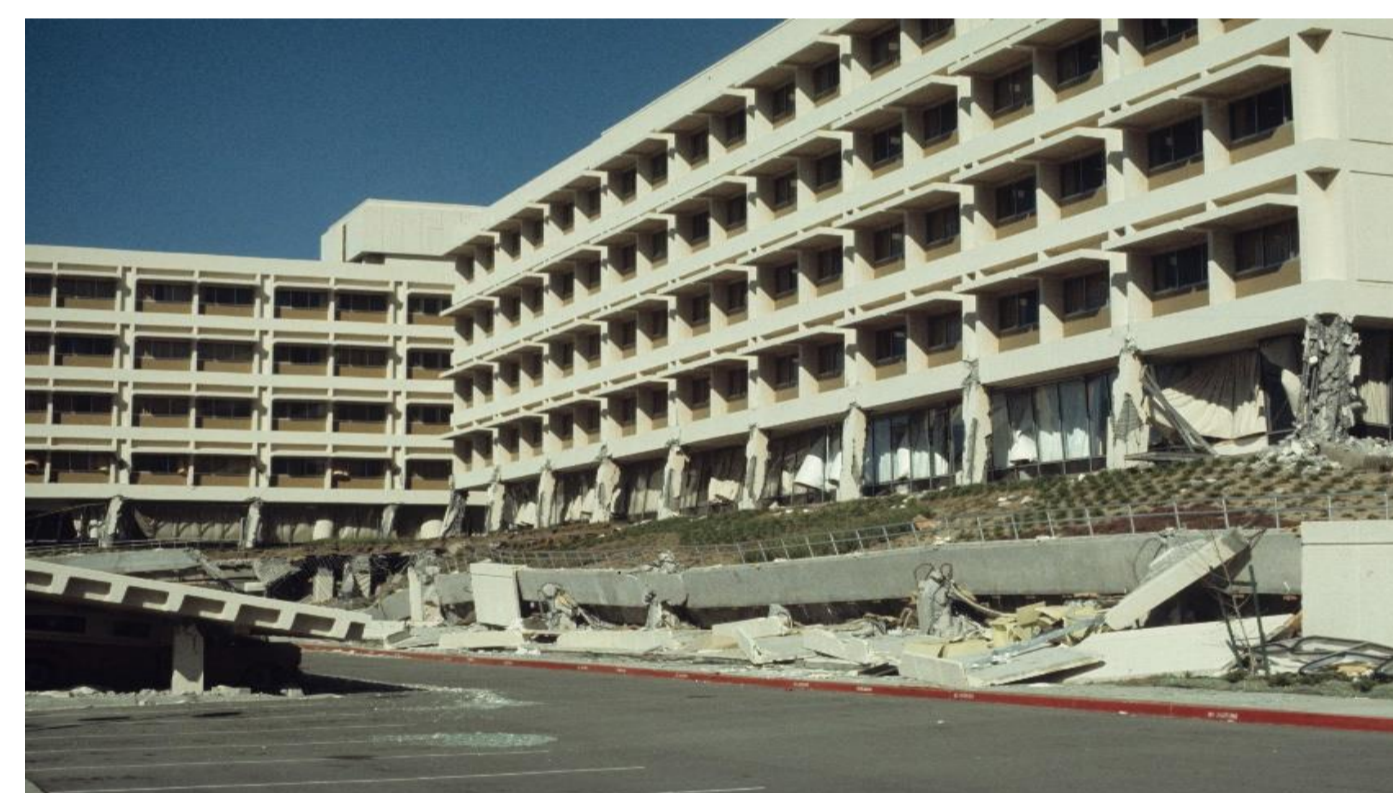
Fig. 1 – Soft Storey Collapse of Olive View Hospital 1971 San Fernando earthquake .

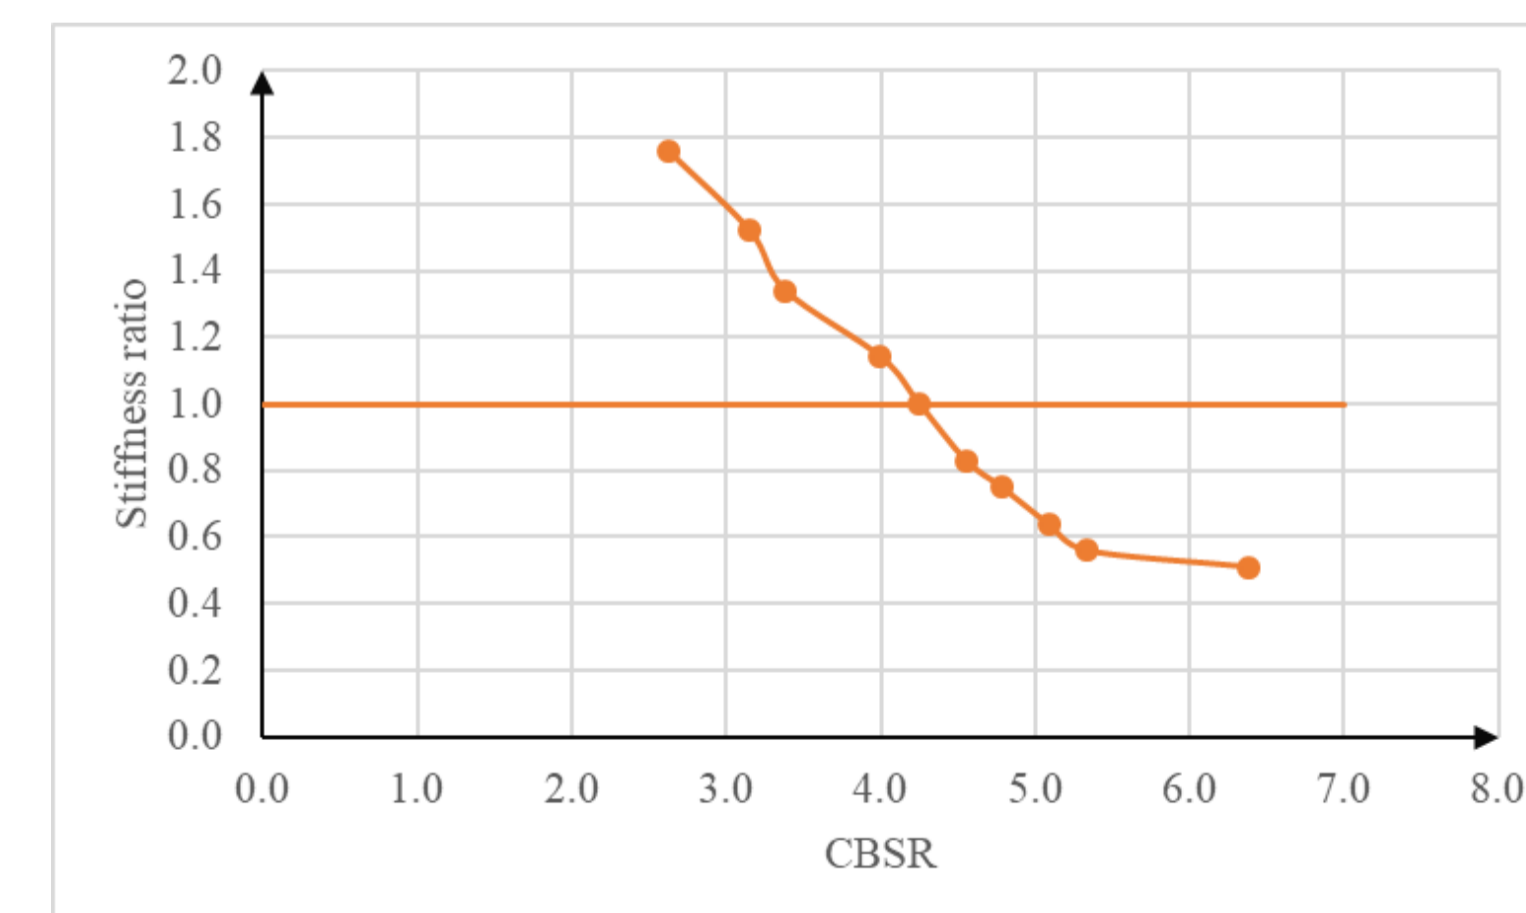
Fig. 4 – Dependence of stiffness ratio with column-to-beam strength ratio for open ground storey

- Increasing stiffness of the open storey and flexural strength of beam-column joints together help preclude the undesirable open storey mechanism in open ground storey buildings,
- Desirable stiffness ratio range is 1 to 0.6, alongside a CBR range of 4 to 5, to preclude the undesirable open storey mechanism in open ground storey buildings,
- Intermediate open storey buildings demonstrate extremely poor seismic behaviour, and hence are not recommended
